Management of Natural Disaster Mitigation and Response Programs for Historic Sites

1994 Northridge Earthquake: case study, Los Encinos State Historic Park, Garnier Building

THOMAS A. WINTER

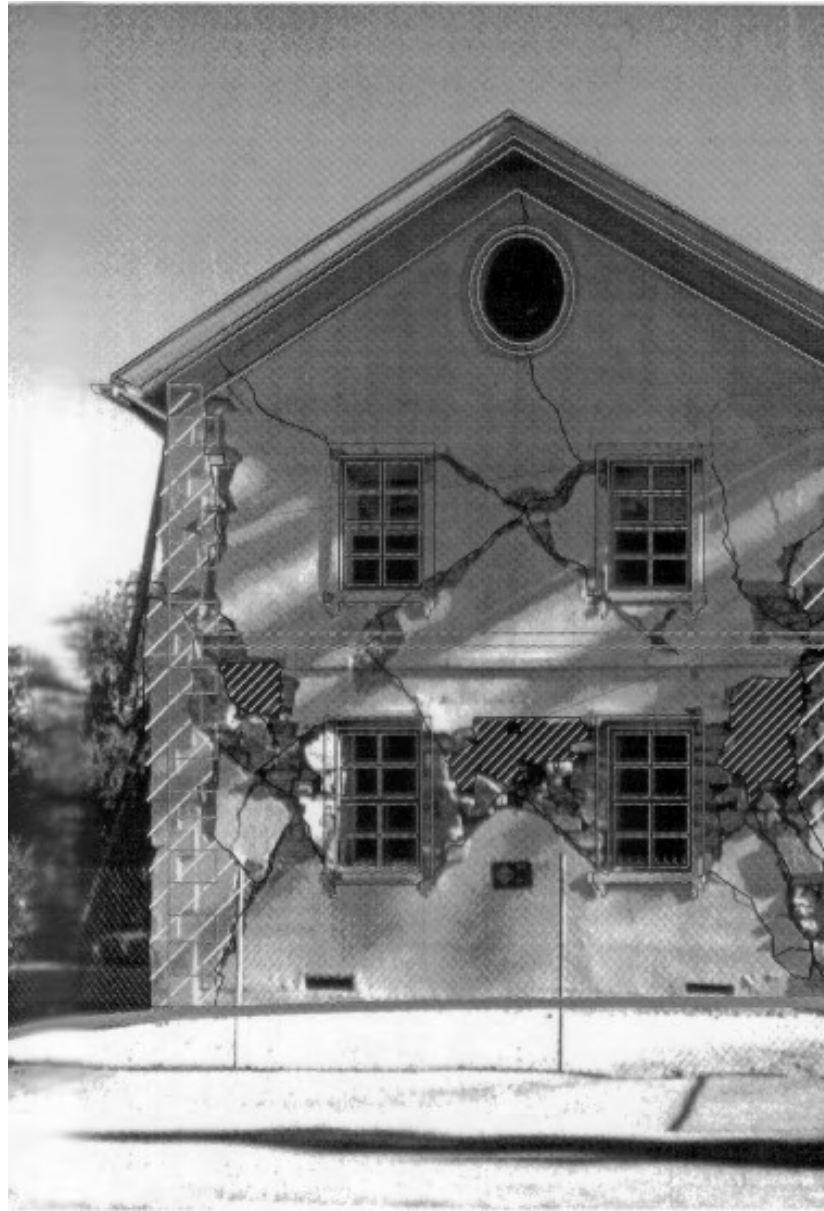
North elevation.

The north elevation suffered severe cracking such that the area between the lower windows collapsed, leaving two small piers of masonry supporting the continuous header over the windows. The building corners, which had no anchors within the width of the wall, dislodged and are immanently in danger of collapse. The lack of corner anchors has been noted as a deficiency and current unreinforced masonry design includes corner anchors. The masonry above the second-floor windows remains in good condition with little cracking. This masonry was tied into the roof and second-floor ceiling structure during the retrofit.
